RESEARCH RESULTS OF THE PAHSADEVOR (CLAY WALL) DEPARTMENT AT THE TERRITORIES OF KARAKALPAKISTAN

Nadjibullo Kaliev

Assistant of professor at the Department of "Architecture and Urban Construction" of Karakalpak State University named after Berdak, Nukus city, Republic of Karakalpakstan

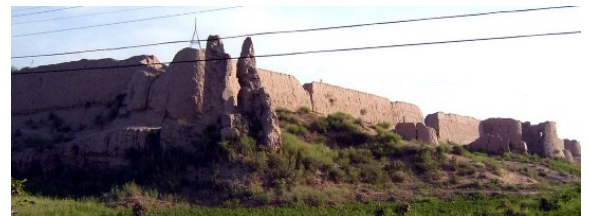
This Fortress, inspired by the XII century "Great Guldursun Qala" wall, is located in Ellikqala district of Karakalpakstan (Figure 1). It has an improper rectangular shape, measuring 350 x 230 meters [4]. The

Figure 1. A general view of the "Great Guldursun Fortress" wall

walls of the ancient walls have been preserved in 13 to 15 meters in some parts of the wall. Their crotch is made of crude material, and its top is made of 40x40x10 cm of crude brick.

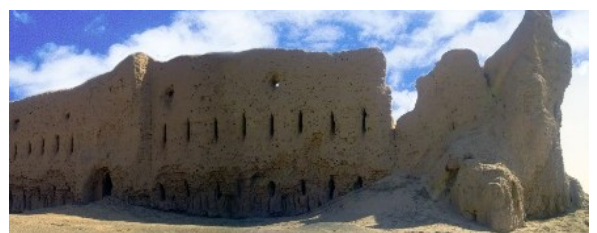
The "Gavur Kala" IV-III century architectural monument is 200x450x400 meters (Figure 2). In some places, the wall is up to 15 meters high.

Figure 2. A general view of "Gavur Kala"

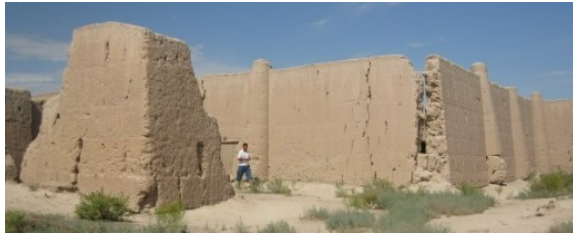
An architectural monument of the XIX-XX centuries known as "Ichan Kala (Inner fortress)" is located in Kegeyli district of the Republic of Karakalpakstan (3rd place). The Fortress plan is in rectangular shape and measures 120 x 145 meters. Ichan Kala (Inner fortress) has 50-70 rooms built in the first building period, and it has been rebuilt for a large residential building.

Figure 3. A general view of the "Ishan Fortress" wall

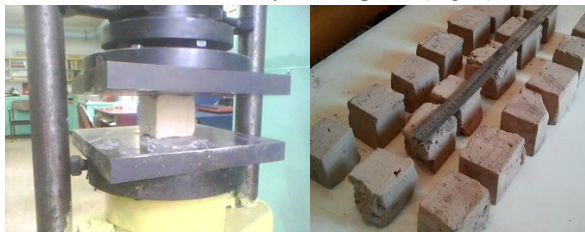
In Table 1, the strength of the samples cut in cubes from "Gavur Kala", "Ichan Kala (Inner fortress)" and "Katli Guldursun Kala" were determined by laboratory tests. The dimensions of the cube samples were duplicated (Fig. 4).

1. For the first group sample - 100 mm;
2. For samples of the second group - 50 mm. Samples were tested on the PG10 hydraulic press (Fig. 4).

Figure 4. Clay samples on the press and appearance of specimens prepared.

Methods for testing concrete samples were tested in accordance with KMK 2.01.03-96 "Construction in earthquake zones" [5].
